Manhole Inspection Summary

Manhole # S23SS1005MH

Location Address: **4909 FALLS RD**

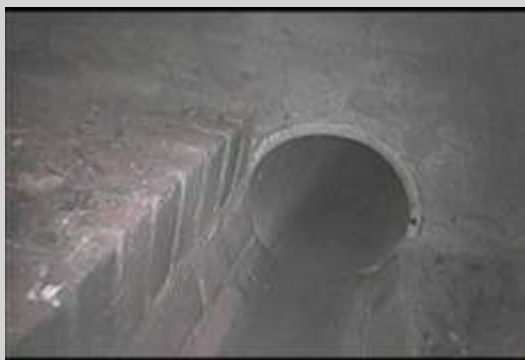
8 in. Circular Gravity Sewer Pipe In @ 6 O'Clock

Rod and Bar (Angled)

Pipe Material: **Clay** ☐ Pipe Lined

Invert Depth: **5.68** (ft.) Flow Characteristics: **Slow**

Infiltration: **None** Pipe Seal Cond: **Unknown**

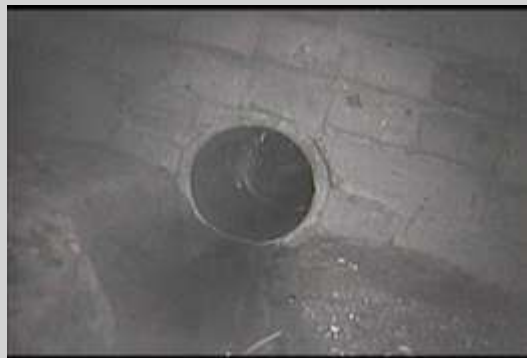
6 in. Circular Gravity Sewer

Rod and Bar (Angled)

Pipe Material: **Clay**

Infiltration: **None**
